# Manhole Inspection Summary

Manhole # S27K\_\_012MH

Insp Date: **6/3/08 10:06 AM**

**Location** Address: **829 Mc Henry (behind house)**

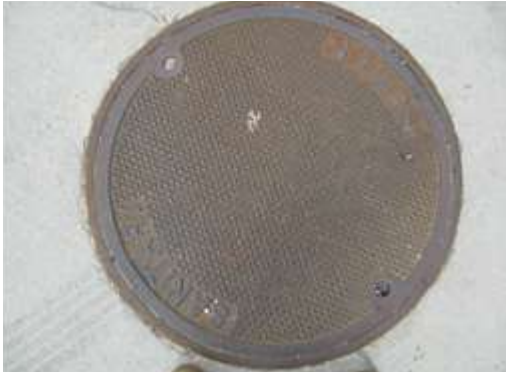
Cover View

Condition: **Sound**

Condition: ☒ Sound ☐ Cracked ☐ Leaks

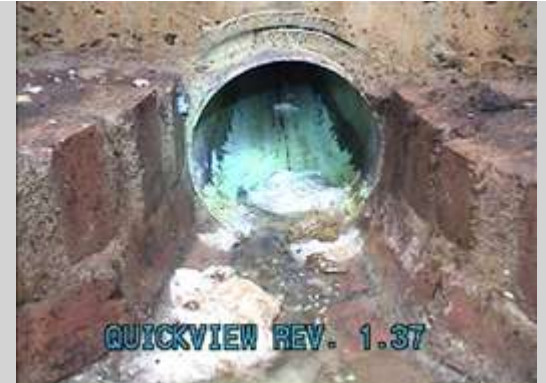
12 O'Clock Outflow

8 in. Circular Gravity Sewer  
Pipe Out @ 12 O'Clock

Pipe Height: **8.4** (in.) Rod and Bar (Angled)  
Pipe Material: **PVC** ☐ Pipe Lined  
Invert Depth: **6.96** (ft.) Flow Characteristics: **None**  
Deposits: ☒ None ☐ Mud ☐ Sludge ☐ Debris ☐ Grease  
Silt Depth: **0** (in.) Deposits Extent:  
Infiltration: **None** Pipe Seal Cond: **Sound**

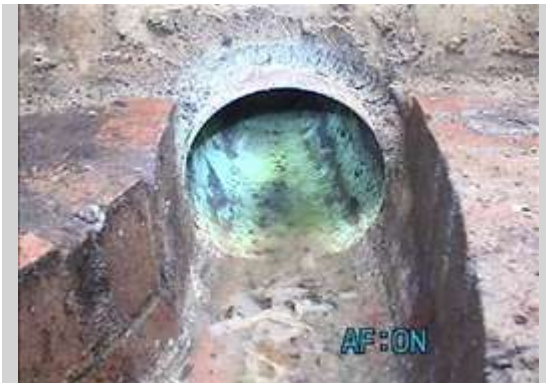
3 O'Clock Inflow

8 in. Circular Gravity Sewer  
Pipe In @ 3 O'Clock

Pipe Height: **8.4** (in.) Rod and Bar (Angled)  
Pipe Material: **PVC** ☐ Pipe Lined  
Invert Depth: **6.87** (ft.) Flow Characteristics: **None**  
Deposits: ☒ None ☐ Mud ☐ Sludge ☐ Debris ☐ Grease  
Silt Depth: **0** (in.) Deposits Extent:  
Infiltration: **None** Pipe Seal Cond: **Sound**

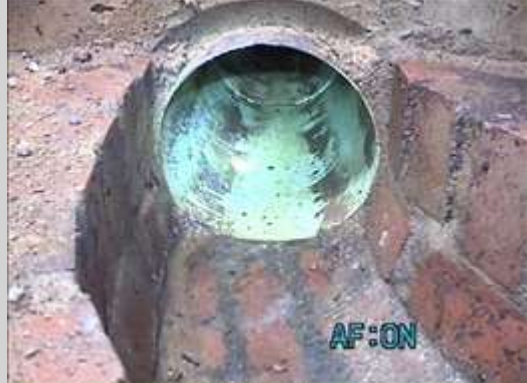
9 O'Clock Inflow

8 in. Circular Gravity Sewer

Pipe In @ 9 O'Clock

Infiltration: **None** Pipe Seal Cond: **Sound**
